Harnai Earthquake-2021

Technical Assessment of Damaged Shelters

10th-11th October, 2021

Shelters fully and partially Damages overview and Failure

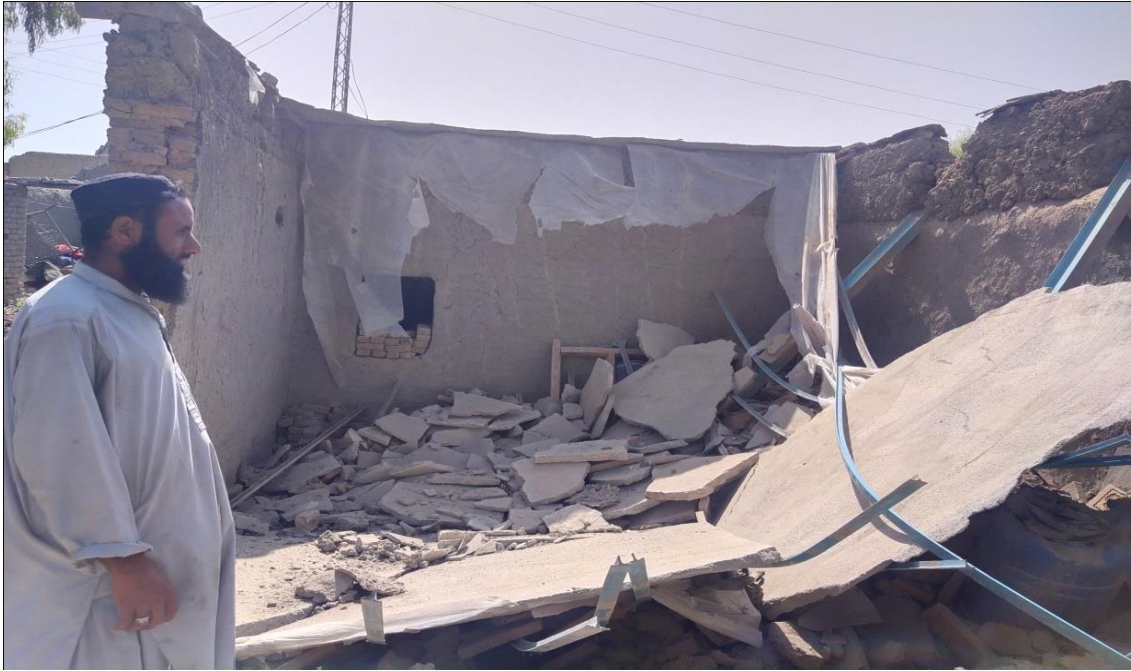
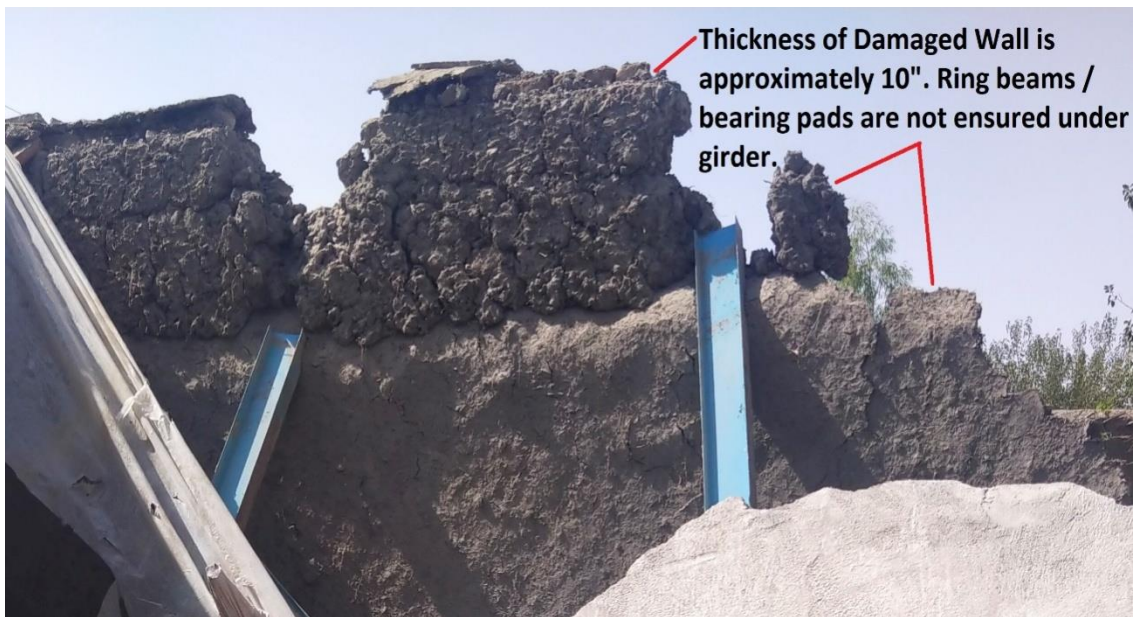
1. Reason: Heavy weight of roof on top of walls with less thickness causes the collapse in earth quake or heavy rain.

House owner is worried about his collapsed shelter

Recommendation: Mud Shelter wall thickness should not be less than 13" inches to 14" inches at top and continuous ring beam must be provided on top of the wall or roof level in order to uniformly distributed load on whole structure. Timber is also used as bearing pads at roof level underneath main Beam or Girder. (Lightweight roof should be used in this type of structures. While Steel Girder and T-iron with roof tile requires a strong bearing structure.

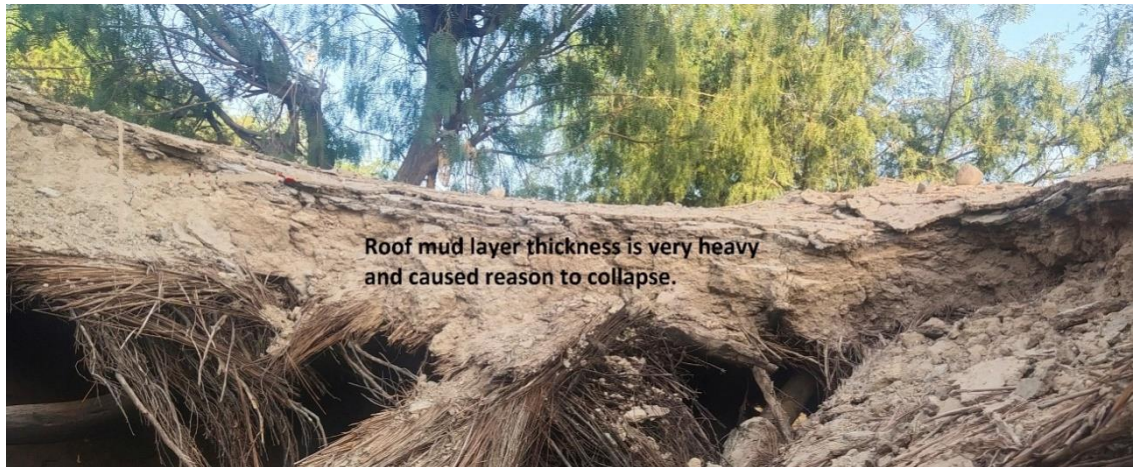
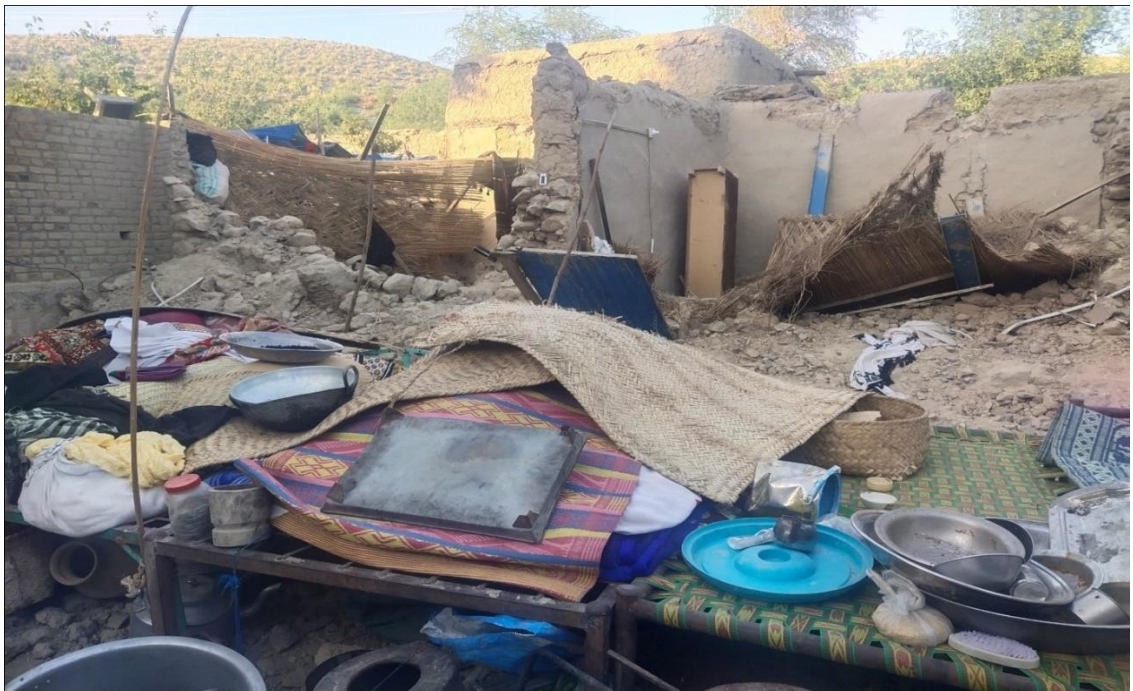
2. Thick mud layer will add a lot of load to the roof and cause of severe damaging strain to the roof structure and load bearing wall. (Common practice in the villages that every year community applies a new mud layer on roof due to heavy load of mud layers including load of Girder and T-Iron with roof tile, the roof will be collapsed in Earth Quake or Heavy rain)

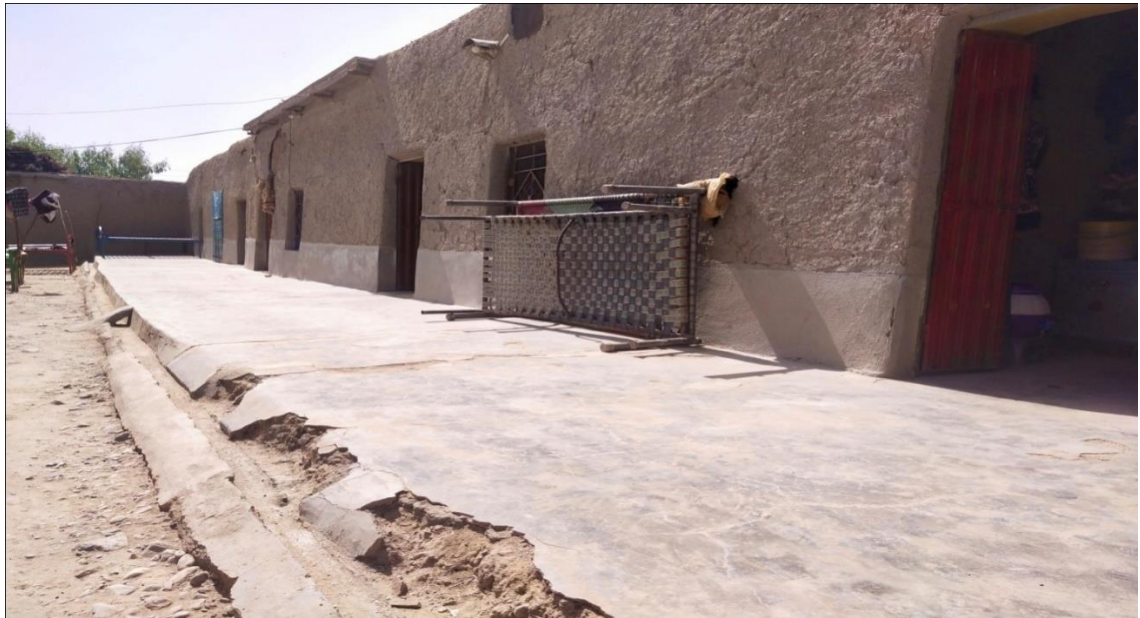
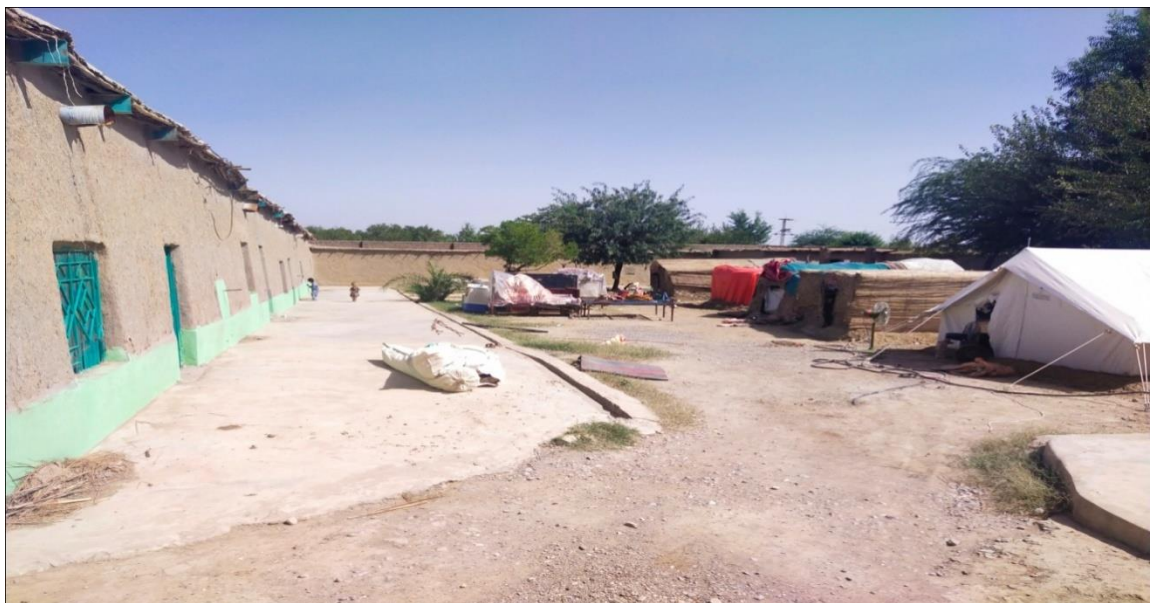
3. Common practice of joint mud shelter construction have seen in few villages and these all affected due to continuous Long span of wall partially damaged from internal side by Earth Quake in all visited villages. Mud wall longer than 14'ft should have intermediate cross partition wall.

Shelter front protection support floor have seen in the villages as good practice in construction by District Harnai community.

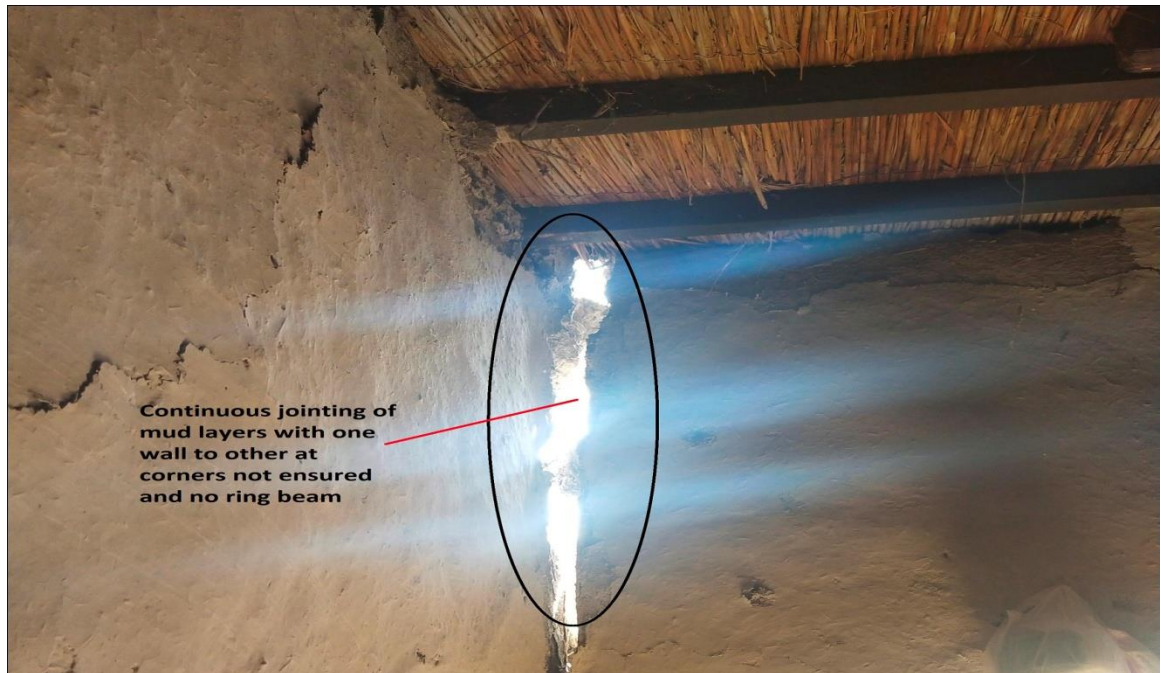
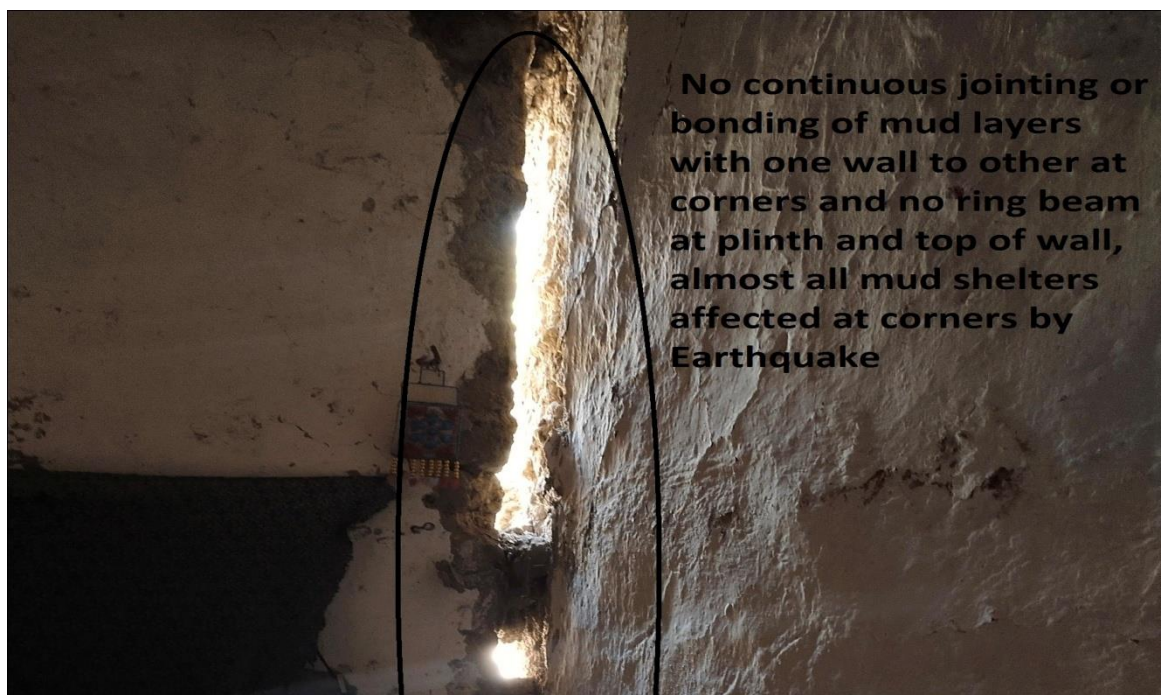
4. Construction gapes in all fully or partially damaged Shelters are same in all visited villages. Almost In all partially damaged shelters corner walls separate from each other; the gap is visible in all shelters. It is observed physically and discussion with community that during construction community is not jointing corners continuously for proper binding or jointing of mud walls.

Standard thickness from foundation to top should be ensured in all mud structures and continuous ring beam on top wall or at roof level avoid the separation of wall and distributed load uniformly on load bearing walls.

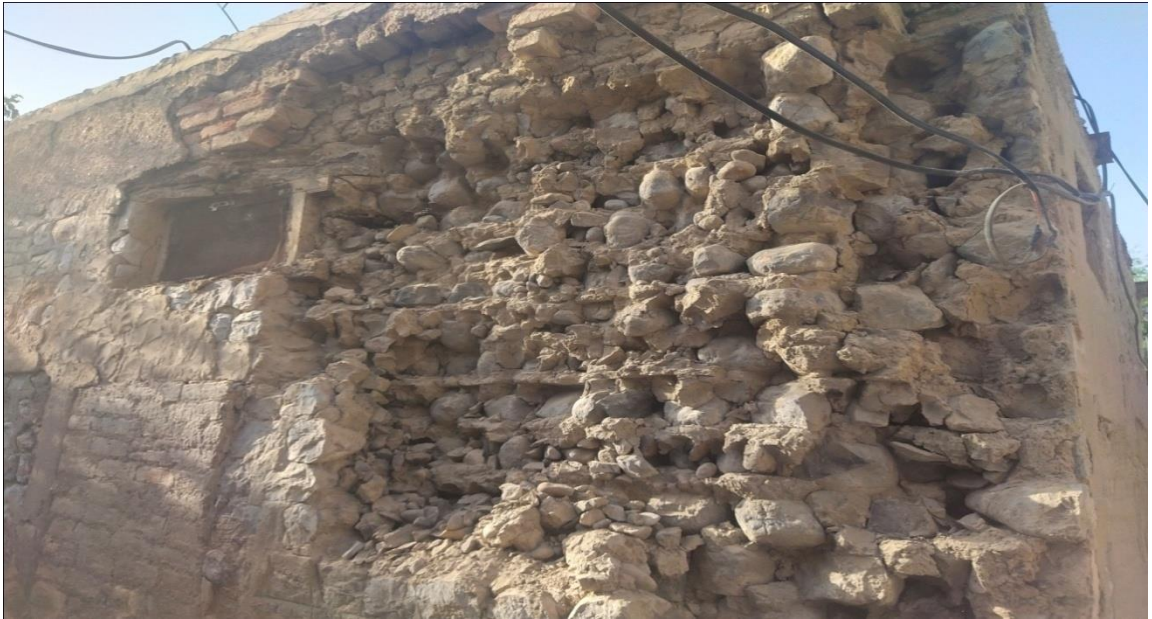
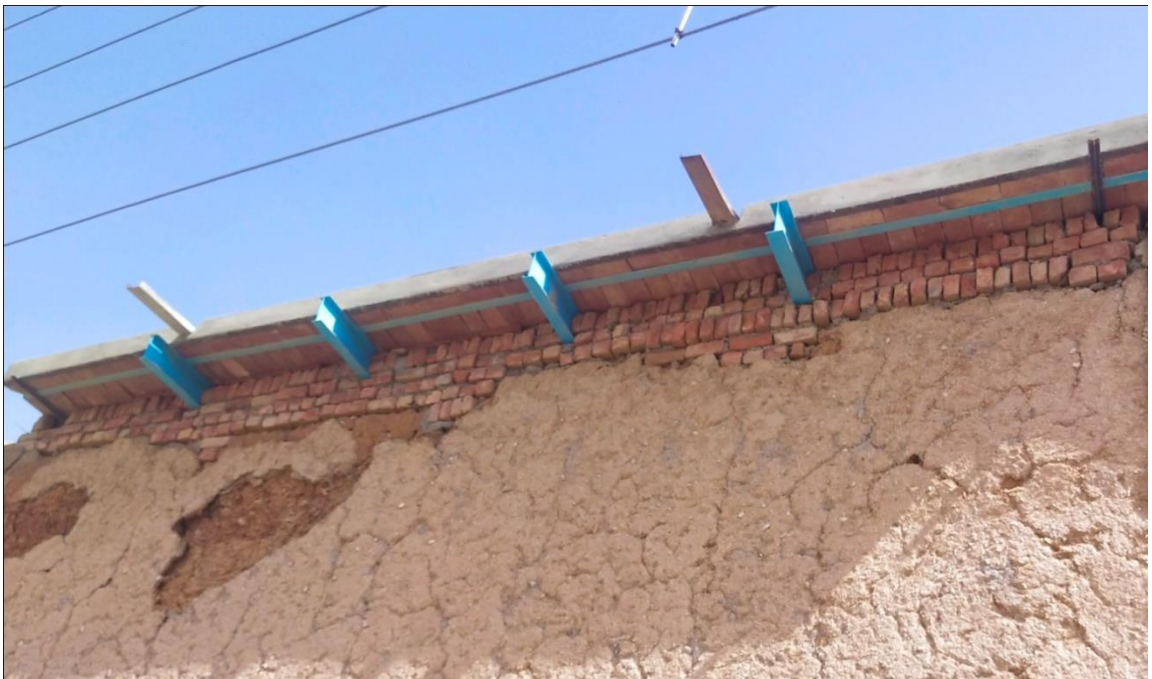
5. Most of the Community using Soil and Stone mix in construction of Mud Shelters but not in all villages.

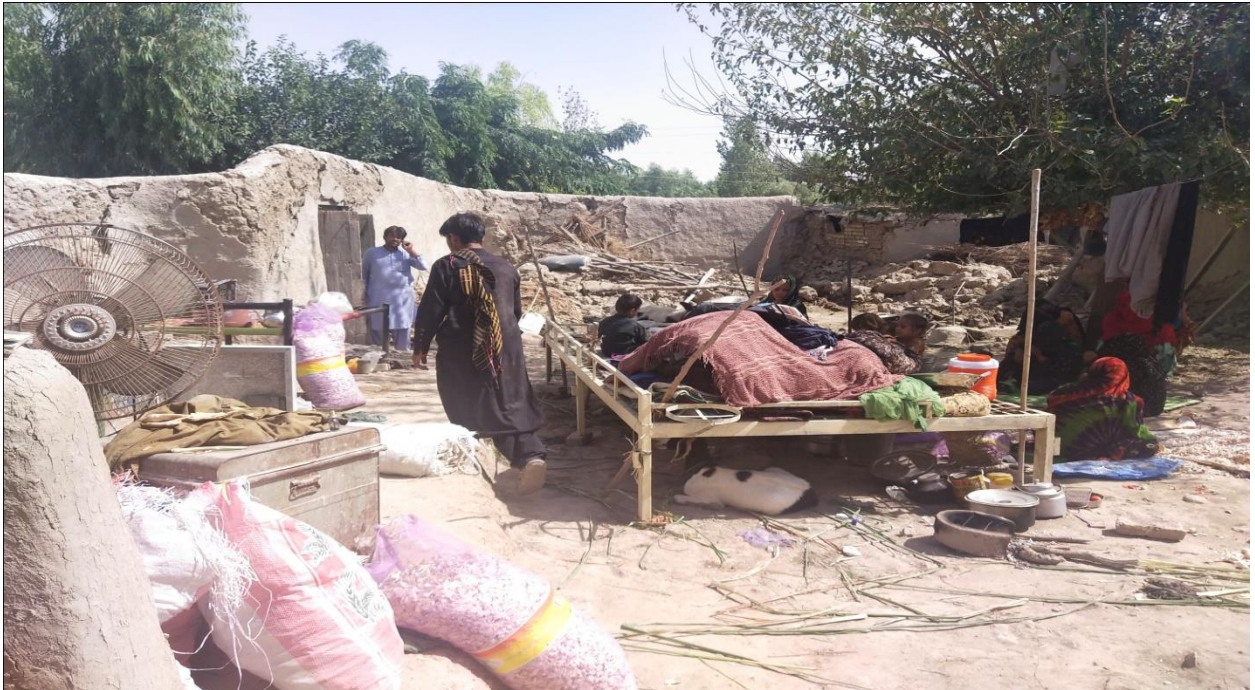
Community females are worried about damaged shelter and waiting for support.

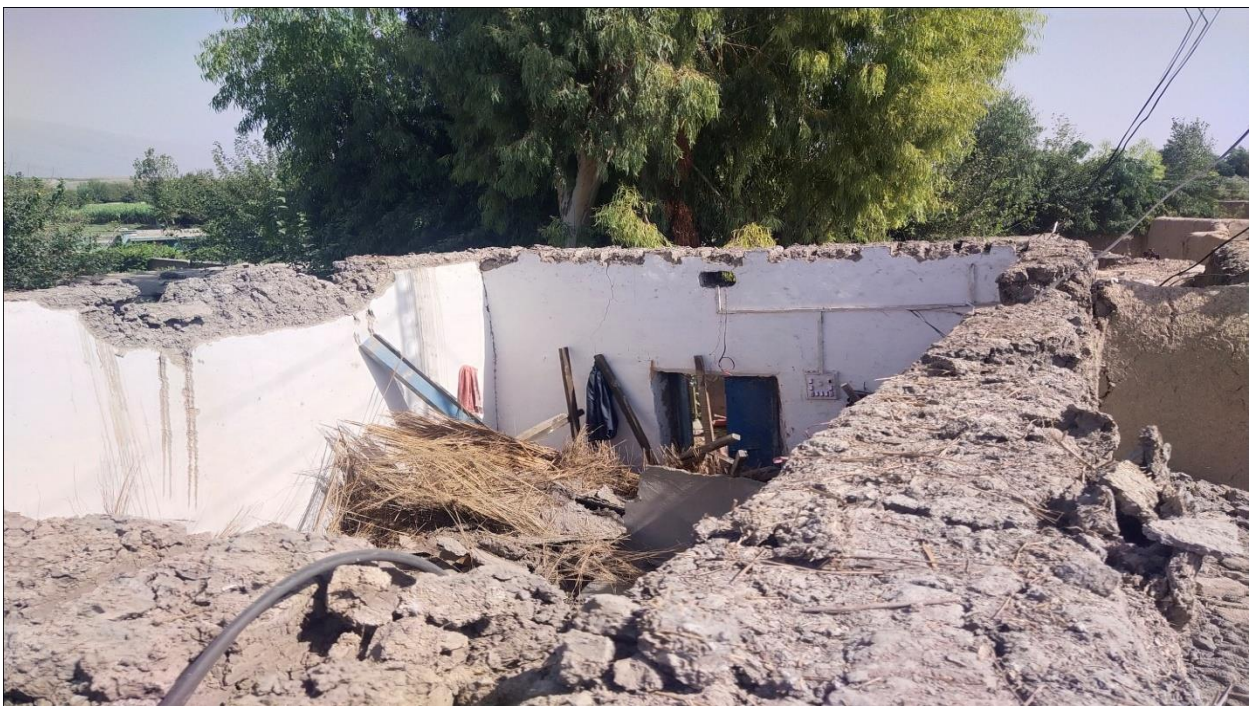
Roof collapsed due to heavy weight roof load by Earth Quake Harnai

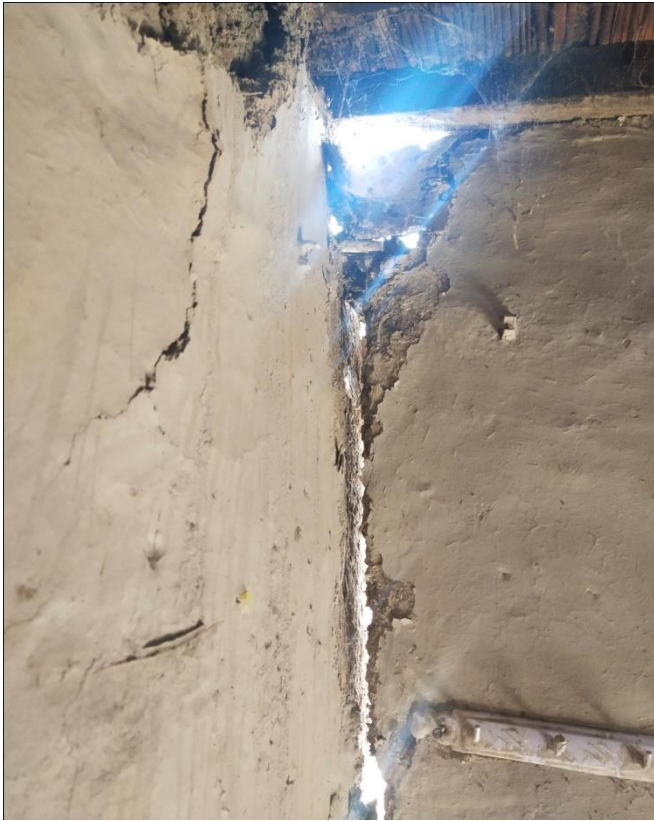
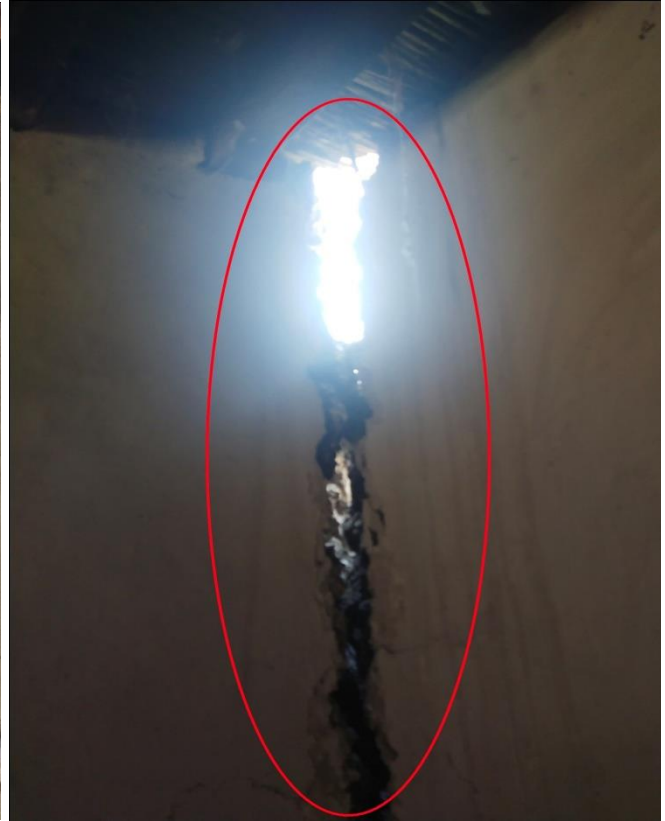
Mud layers from corner walls not joint continuously in all mud shelters affected by Earth Quake

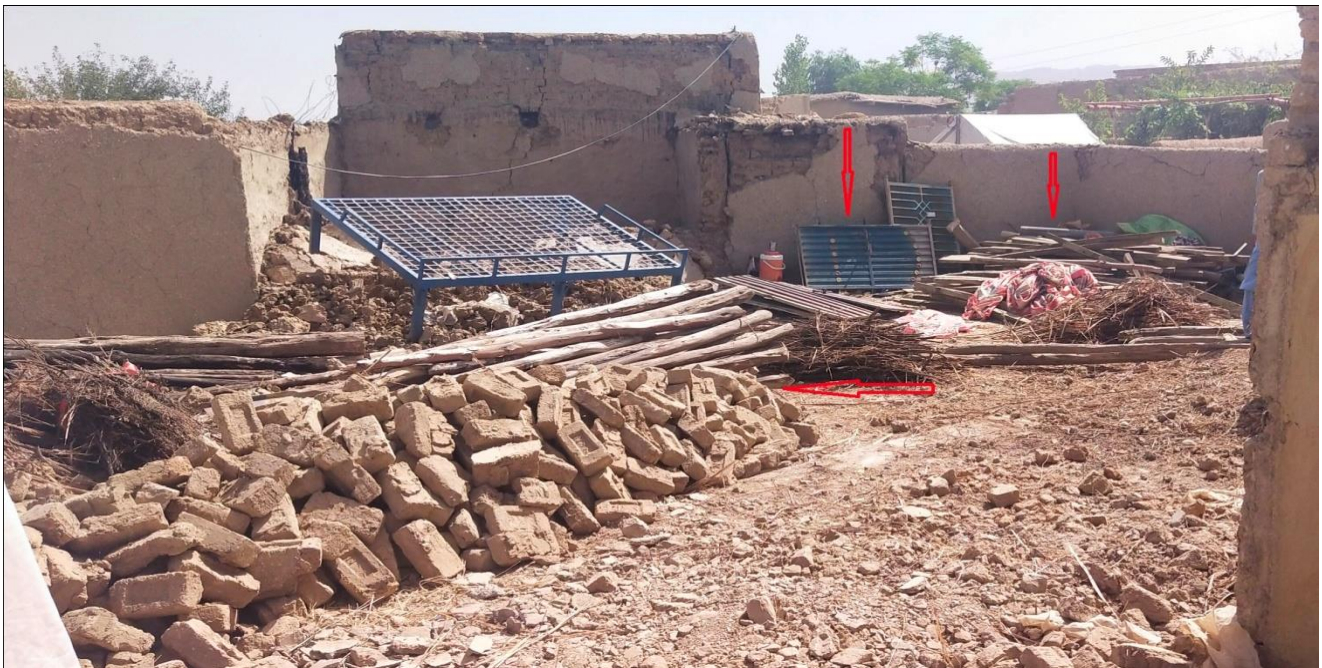
Community started separating their damaged shelter material for reuse in new shelter construction.

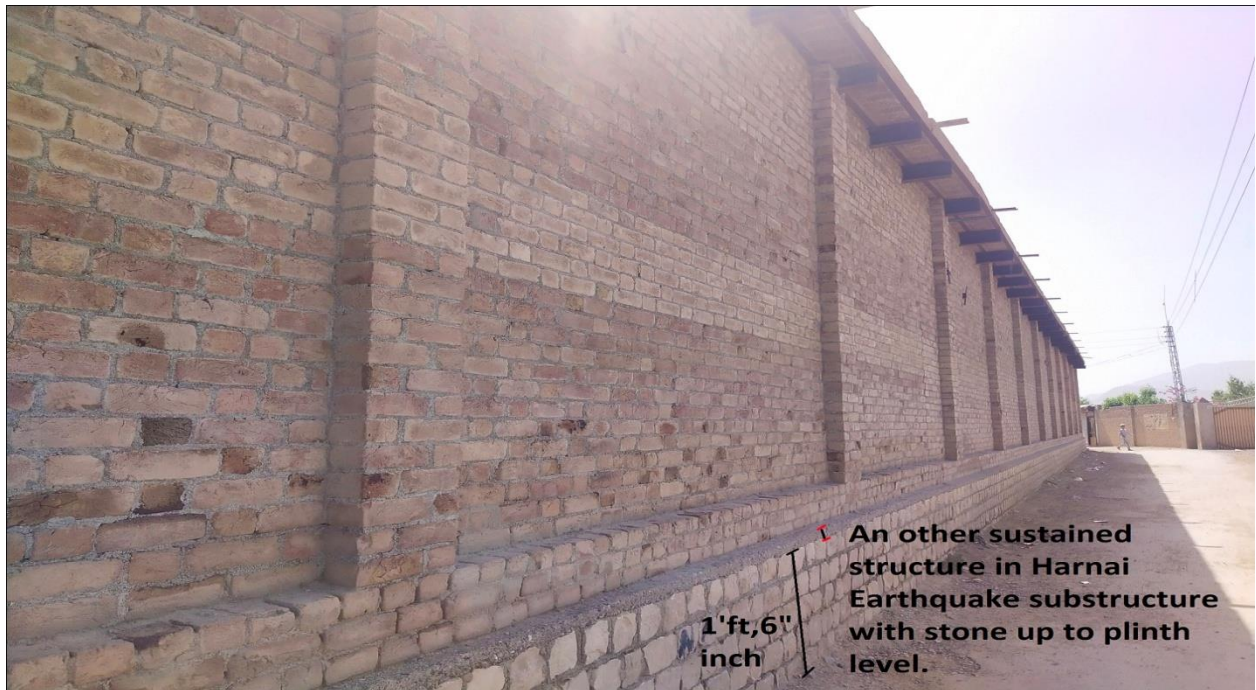
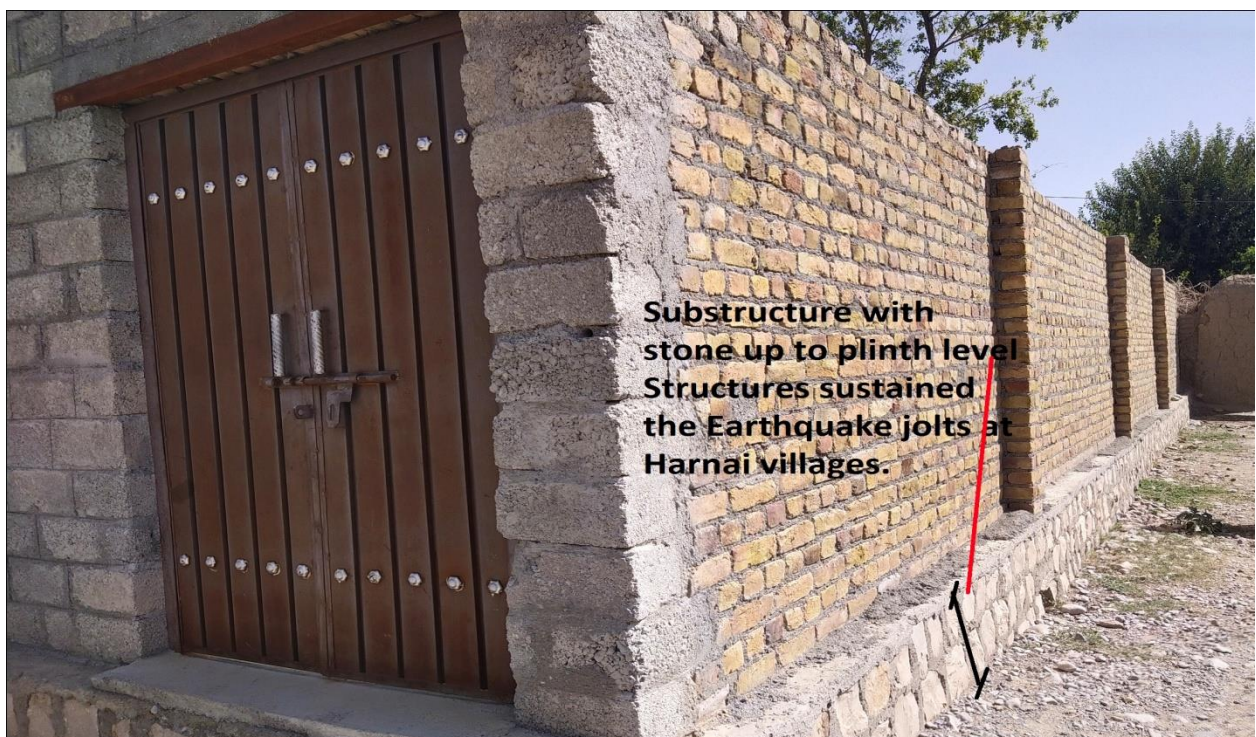
In same villages some structures sustained the jolts and are safe. The below pictures of village Killi Urbooz Total 182 HHs are in this village and estimated 50 mud shelters collapsed down or damaged but shelters with Fired or Pakka Bricks sustained in Earth Quake and the same pattern shelter models found safe from Earth Quake in other visited villages. For Stone masonry community practicing Foundation depth = 1'ft ,6" to 2'ft,6" depending upon the structure, Width = 2'ft to 2'ft,6"inch up to NSL and 1'ft ,6"inch width above NSL with 1'ft ,6" depth with 2" DPC.

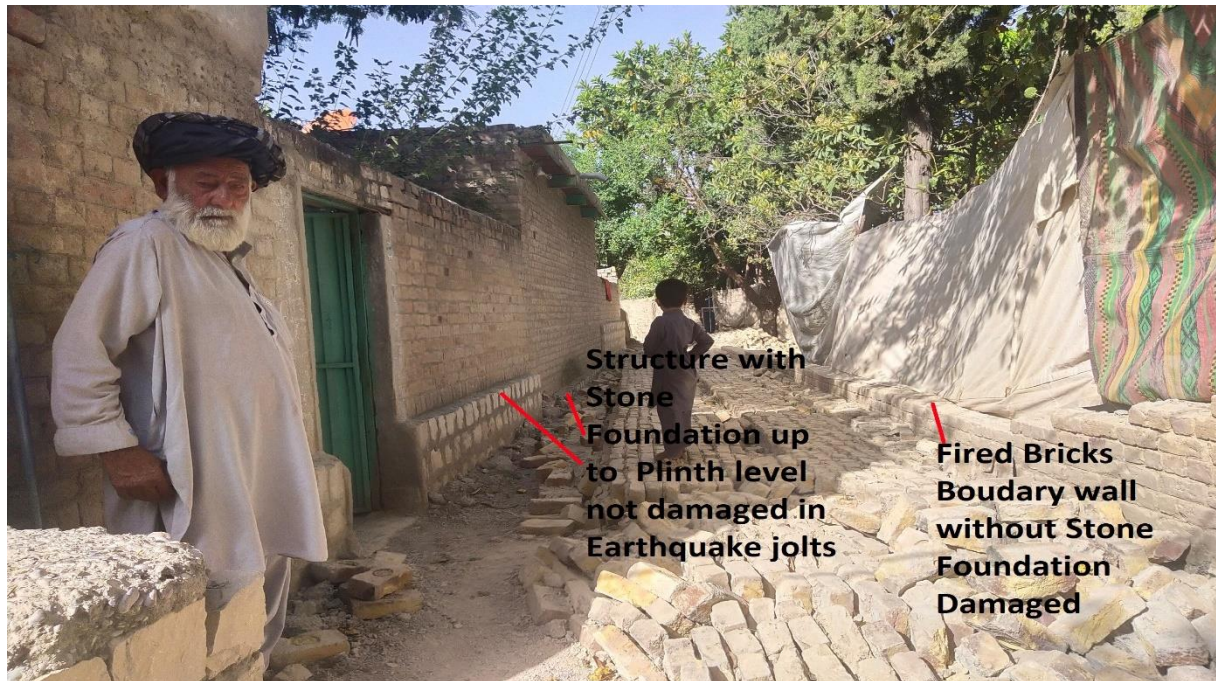
During visit in different villages observed that the sub structure with Stone and Stone masonry up to plinth level in Pakka Shelter or Mud shelters are DRR structures against Earth Quake.

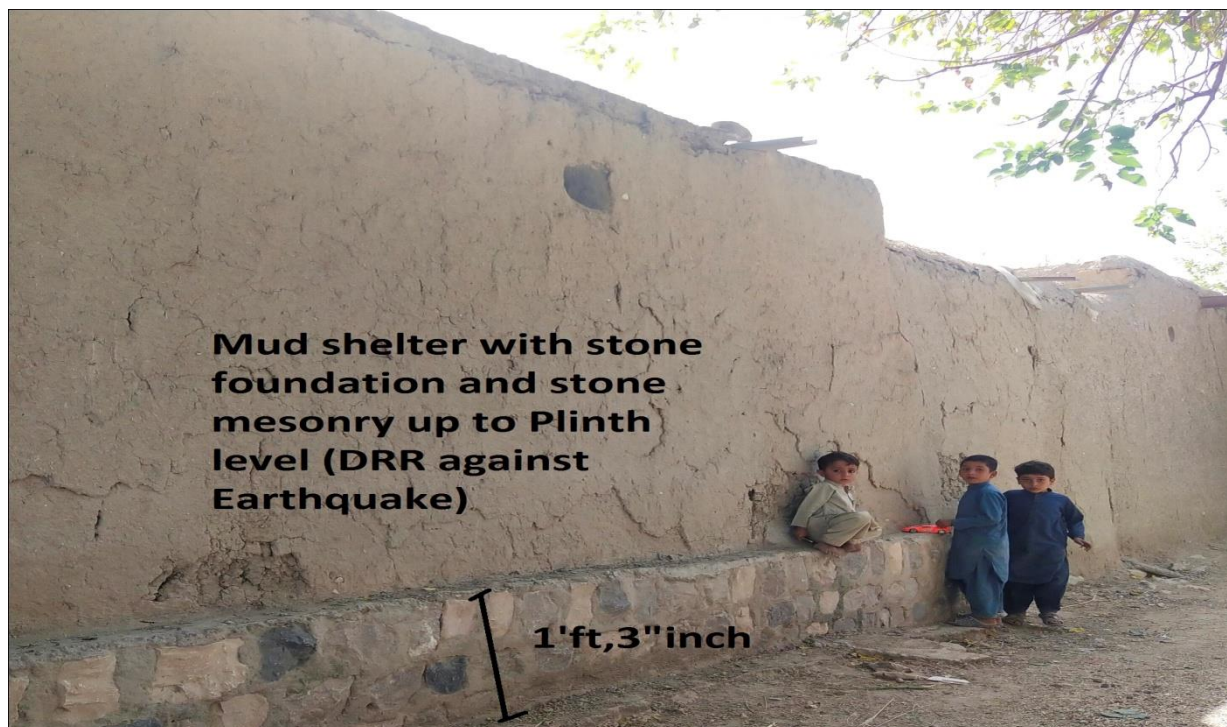
Another example of Mud Shelters sustainable in Earth Quake at Harnai village with using Stone in Sub structure with Width = 2'ft and Depth = 1'ft,6" up to NSL and 1ft,3" inch up to Plinth level.

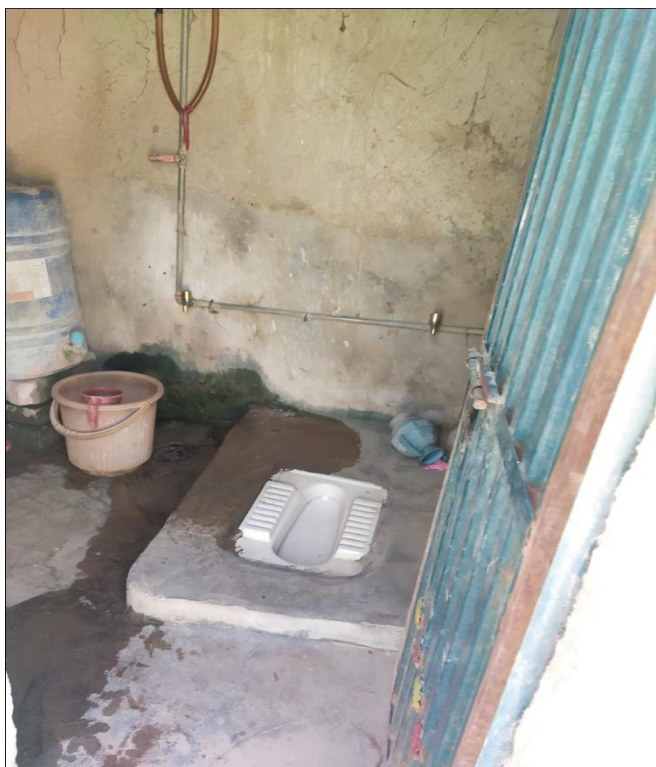
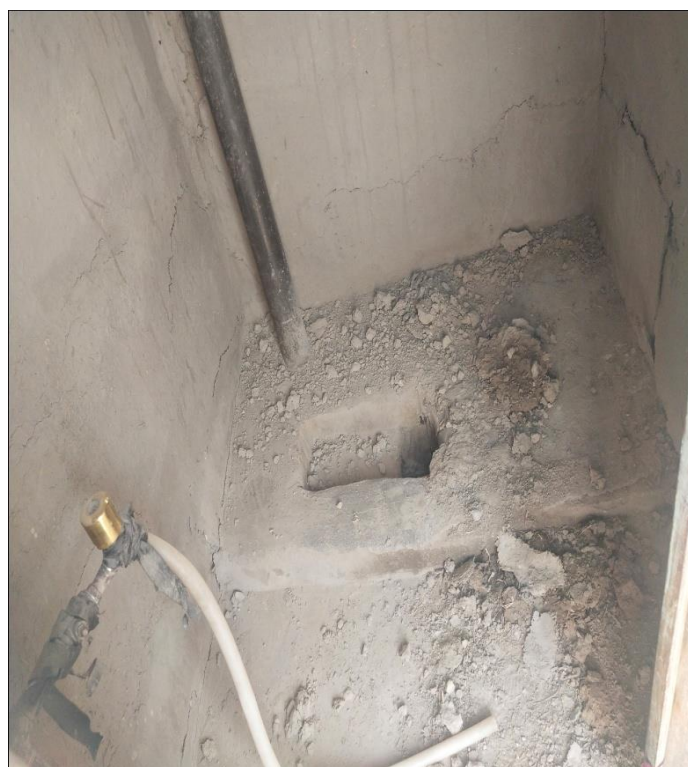
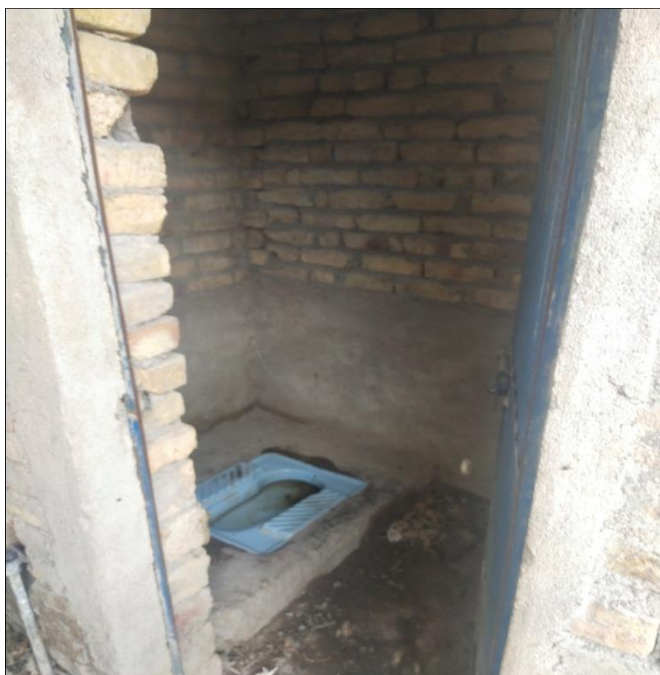
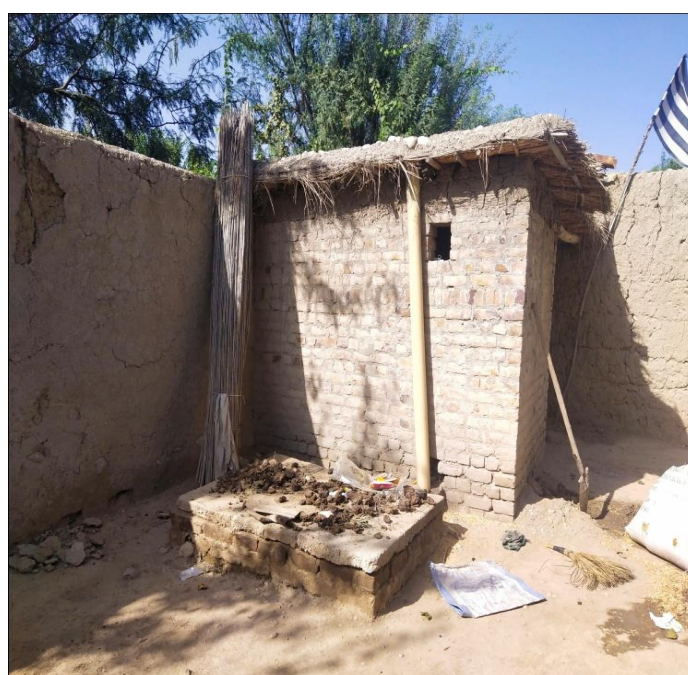
Community facing difficulty after earth quake specially females because latrines damaged in few villages and the condition for female also same as open defecation.
