Harnai Earthquake-2021

Technical Assessment of Damaged Shelters

10th-11th October, 2021

Shelters fully and partially Damages overview and Failure

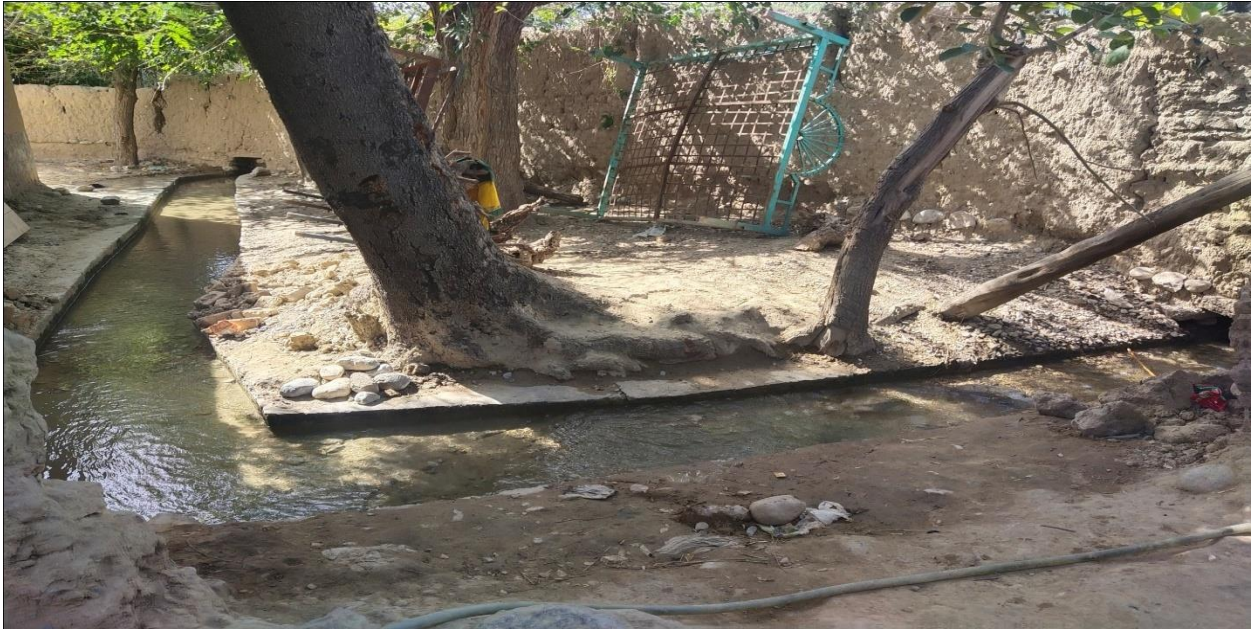
It is observed in most of the villages main water source is mountain river water through Kareza and also Water supply line in Harnai city or few villages nearby. River water from mountains is easy access at their houses. The Government and other organizations also work on pakka channels from river as in attached picture.

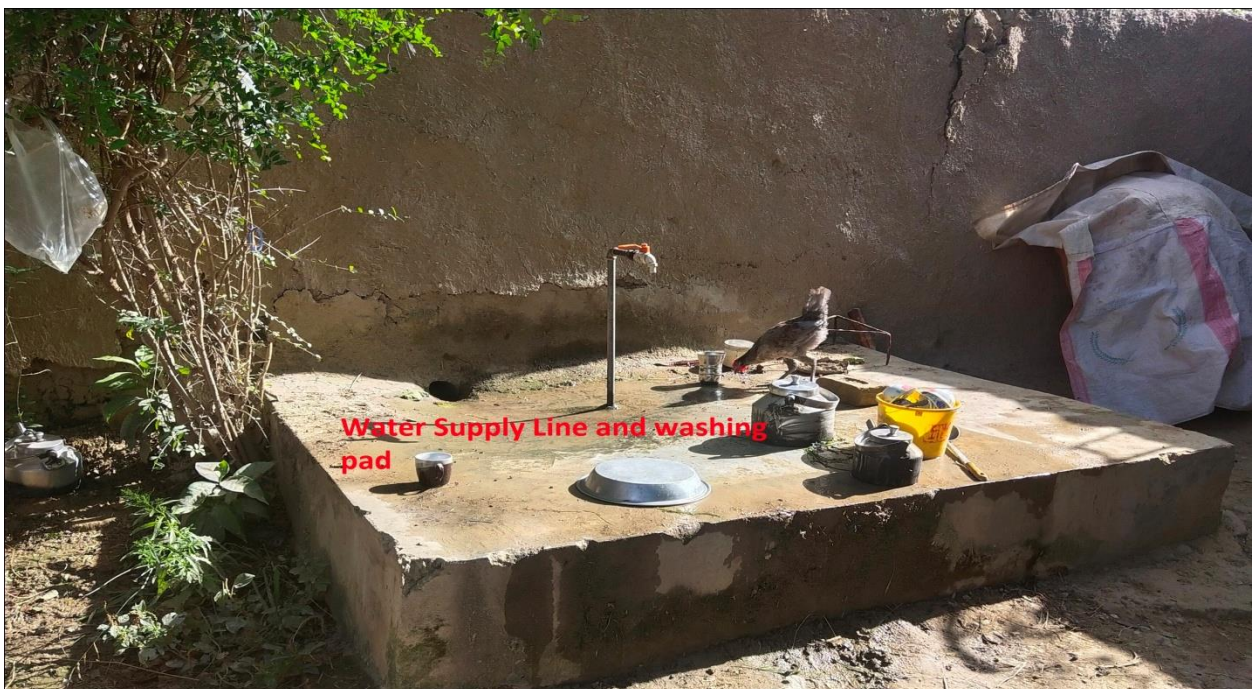
This is a good practice by District Harnai villagers that they constructed washing pad separate or near water supply line in their Houses.

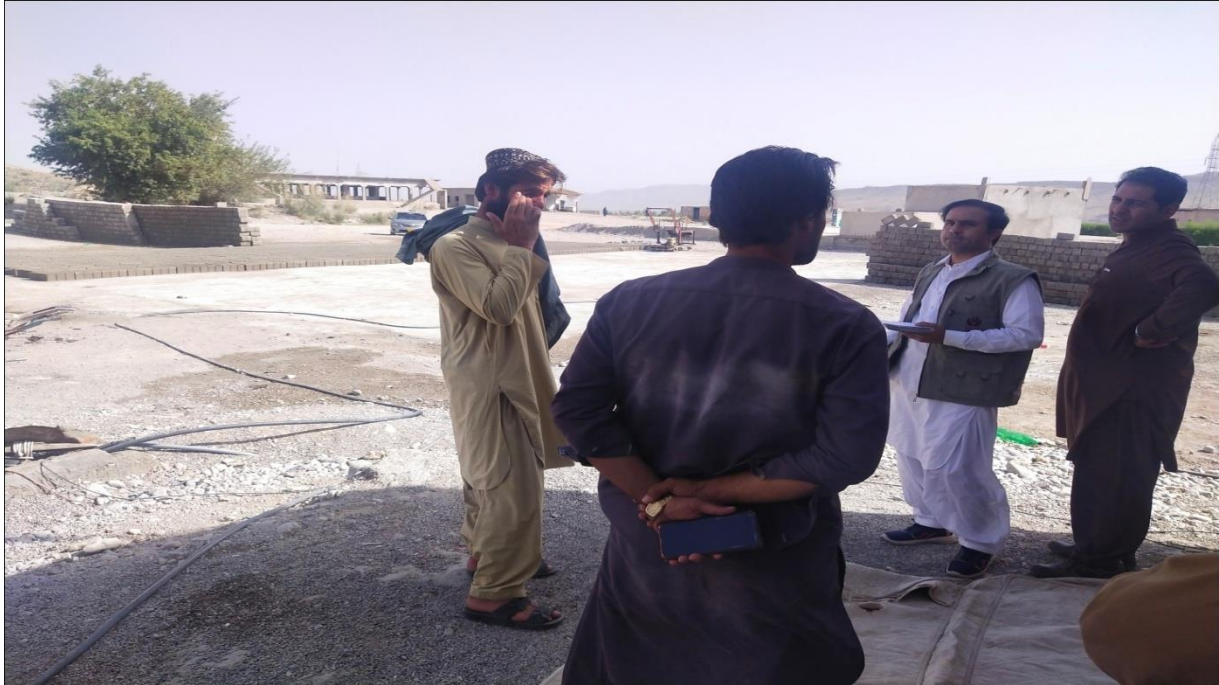
Discussing about rates and qaality of blocks with Block yard owner at Harnai.

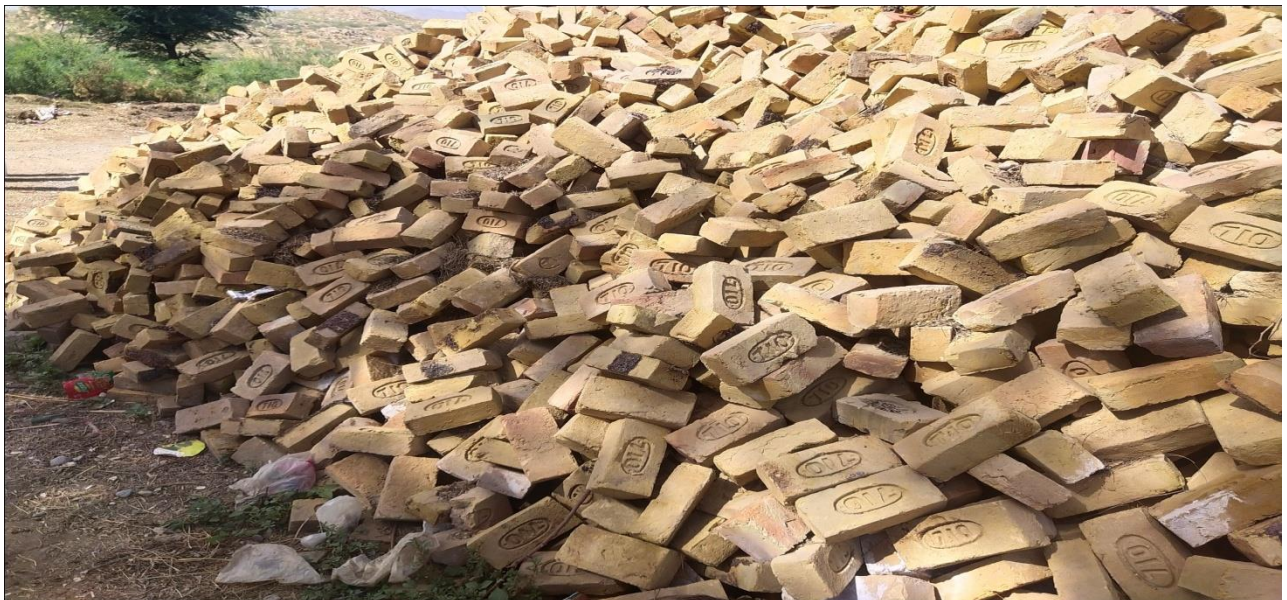
Bricks purched by community person for shelter construction

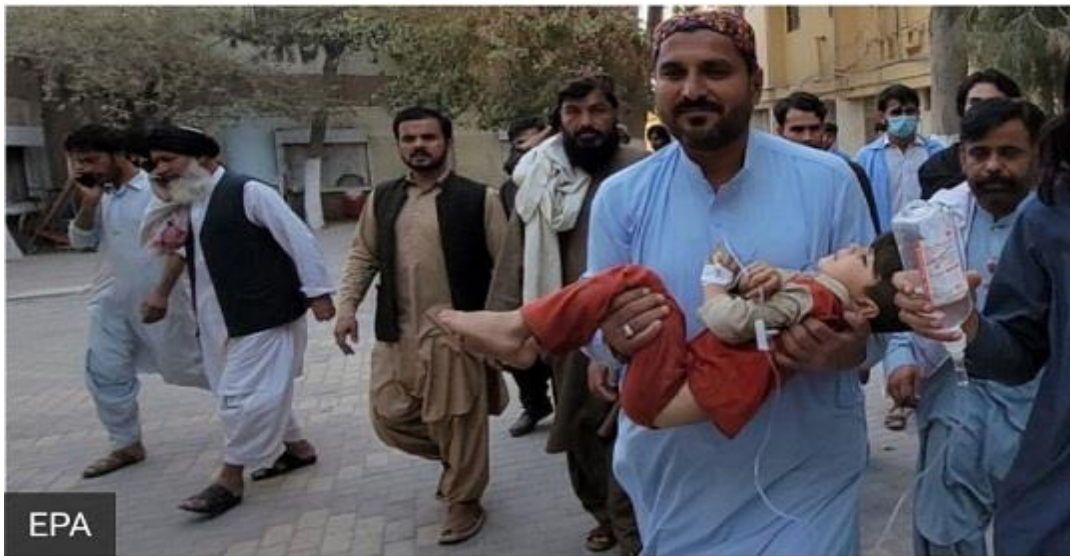
This little Agel was under collapsed Roof of her Shelter due to Earth Quake at District Harnai and she was unconscious for three days in ICU but MashaAllah now she is Happy with her Family.
